## Combustible Dust Explosions and Hazards Case Study: CTA Acoustics, Inc.

John Ahlfield  
Washington University in St. Louis  
Presented to: Robert Anderson  
May 3, 2010

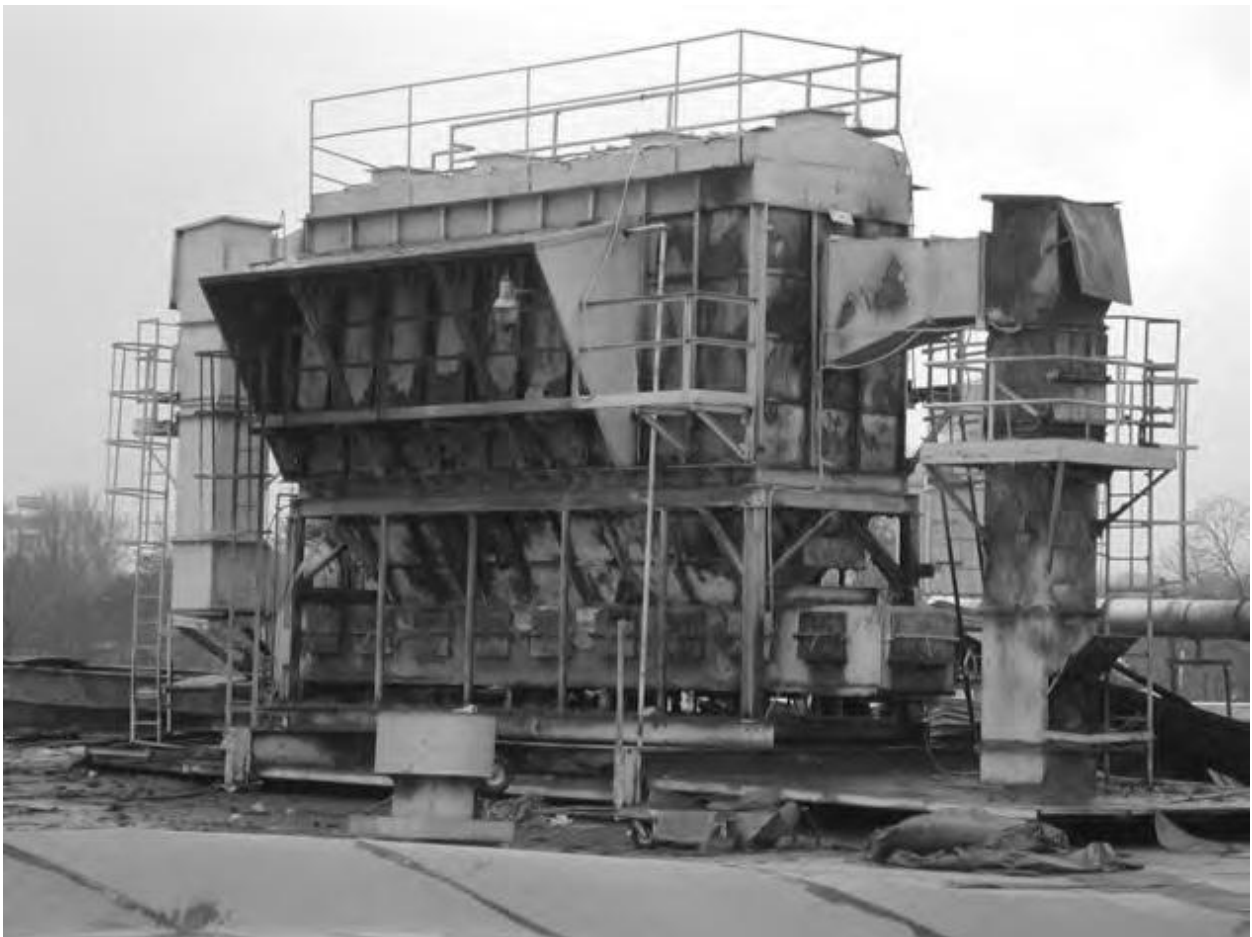
At 7:00 am on February 20, 2003, the baghouse over line 405 was turned off for routine cleaning. At approximately 7:30 am, operators turned it back on. Flames immediately shot through the baghouse system, injuring 2 operators on the roof (figure 2). The curing oven doors were open for manual temperature control. Combustible dust inside the oven caught on fire, causing the flames to shoot up through the baghouse system as it was powered on [CSB 33-34].

Figure 2: Fire damage to line 405 baghouse [CSB 35]

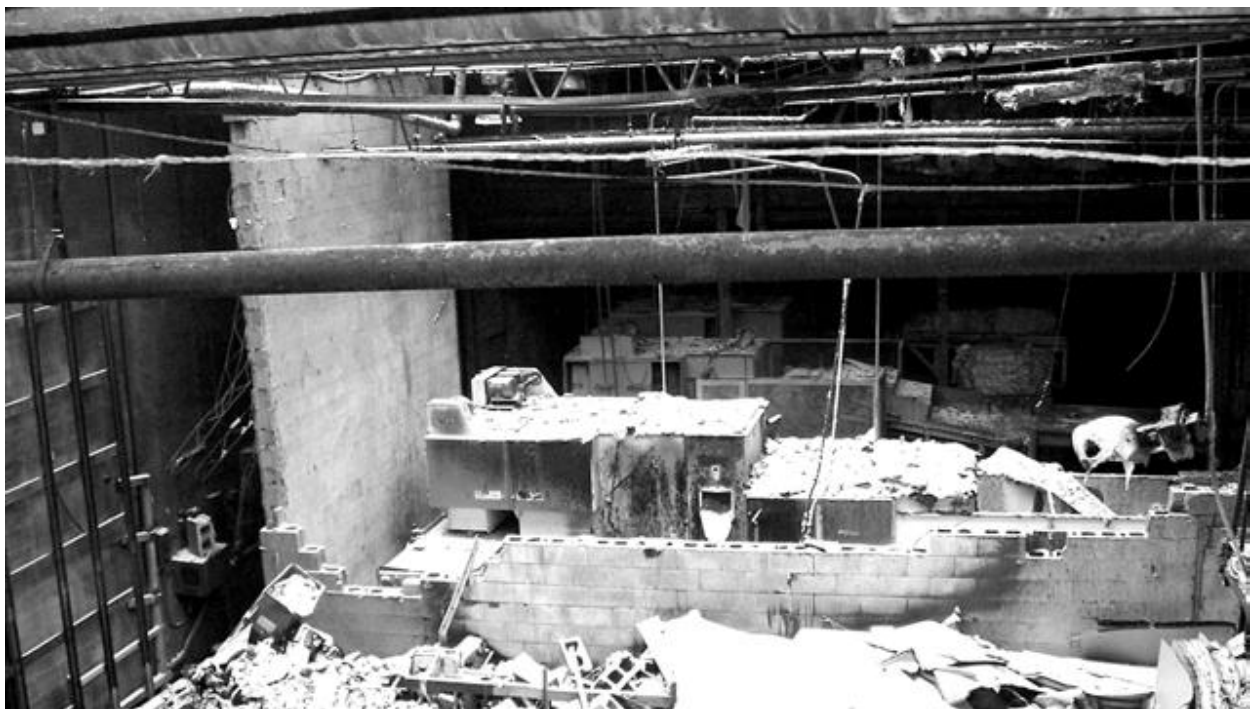
The initial explosion shook loose dust that had accumulated on elevated flat surfaces. This led to a secondary explosion above the blend room for line 405. The pressure wave and fireball resulting from this explosion propagated along the ceiling toward line 403. Due to this pressure wave, the firewall between lines 405 and 403 collapsed (figure 3).

Figure 3: Collapsed firewall between lines 403 and 405 [CSB 38]

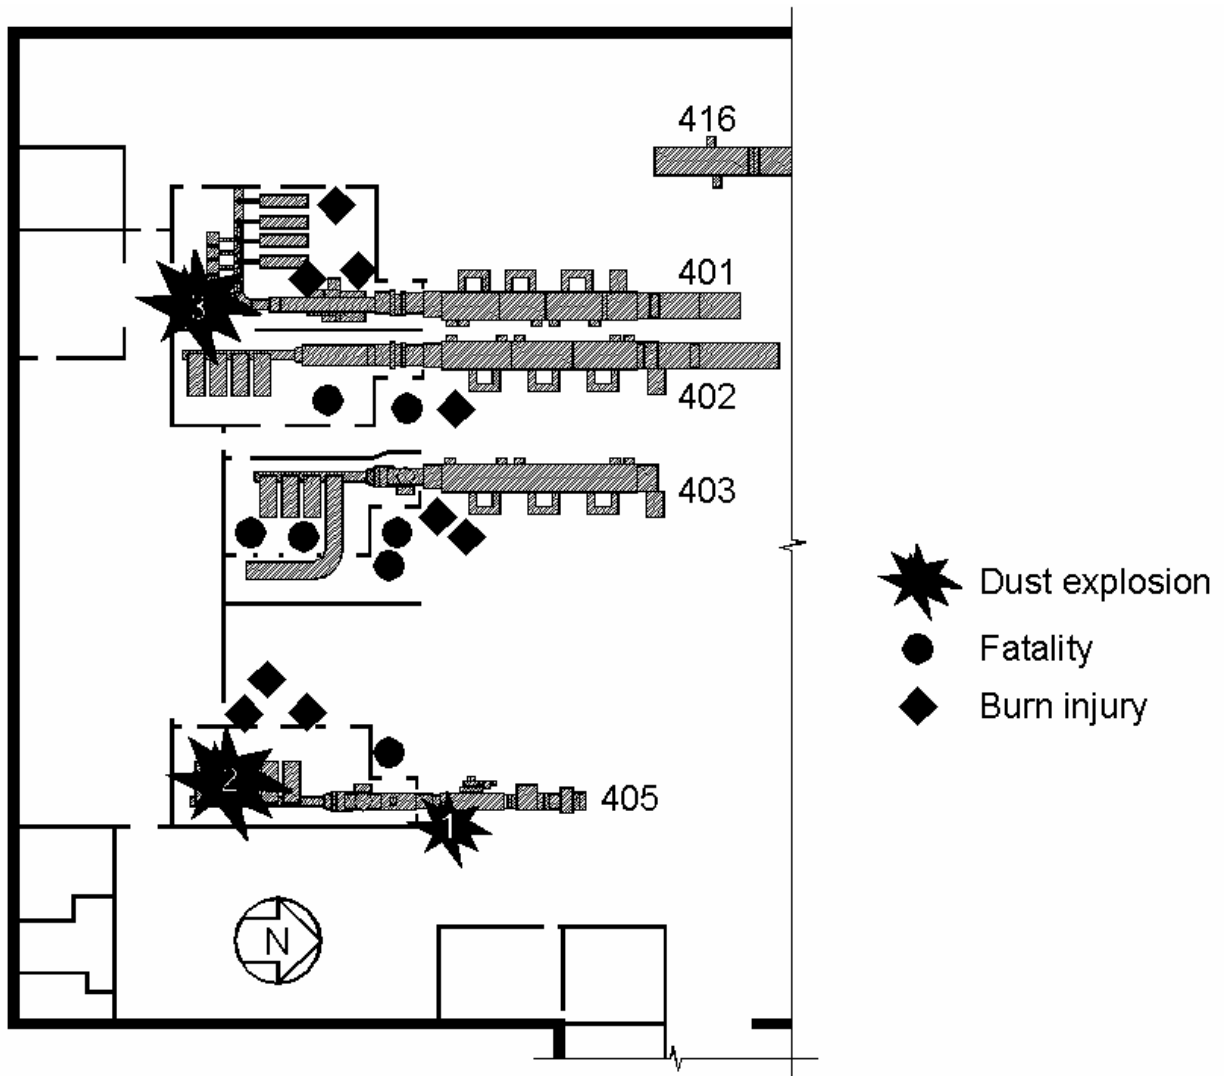
The fireball reached the blend room for line 403, killing 4 more workers. Three more operators were burned between lines 403 and 402; two of them later died in the hospital from their injuries. As the fireball moved west over the line 401 blend room, it ignited another dispersed cloud of dust in a secondary explosion [CSB 36-39].

Figure 4: Sequence of explosions and locations of employees in the production area [CSB 36]
